# Manhole Inspection Summary

Manhole # S51M\_\_036MH

Insp Date: **4/10/08 12:21 PM**

**Location** Address: **930 S Streeper**

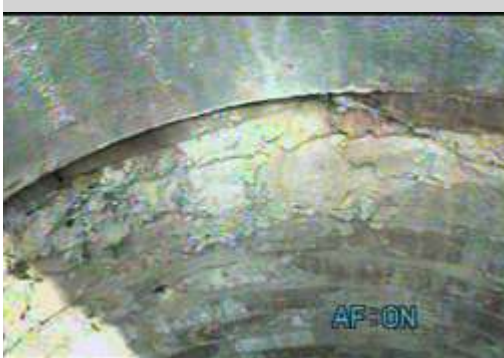
Defect 2

Condition: ☐ Sound ☐ Cracked ☐ Root Intrusion ☐ Loose Brick ☒ **Deteriorated**

Chimney deteriorated, frame adjustment

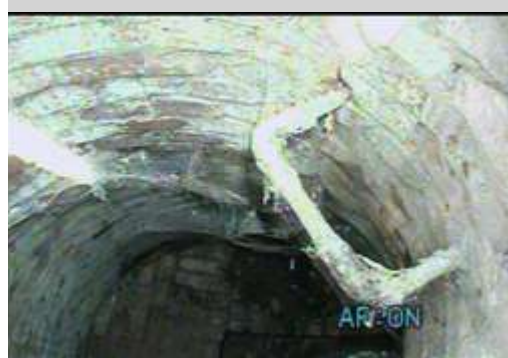
Defect 1

**Steps** Count: **4** Missing: **2** ☒ **Corroded**

corroded stairs

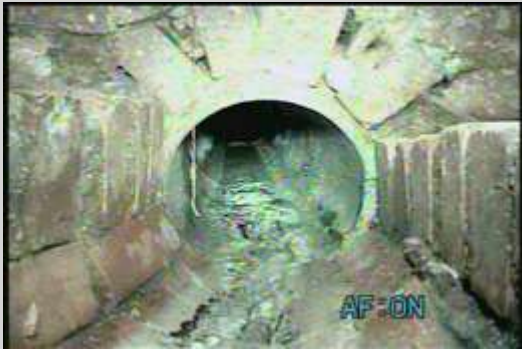
12 O'Clock Outflow

8 in. Circular Gravity Sewer  
Pipe Out @ 12 O'Clock

Pipe Material: **Clay** ☐ Pipe Lined

Invert Depth: **8.80** (ft.) Flow Characteristics: **Fast**

Deposits: ☒ None ☐ Mud ☐ Sludge ☐ Debris ☐ Grease

Infiltration: **None** Pipe Seal Cond: **Unknown**

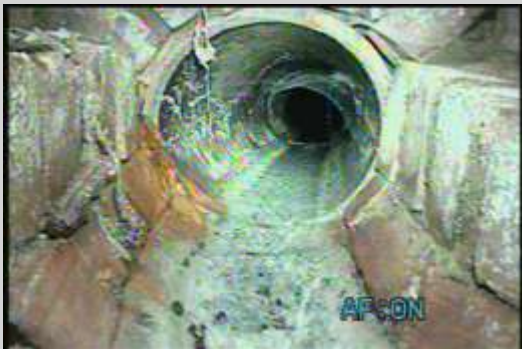
9 O'Clock Inflow

8 in. Circular Gravity Sewer  
Pipe In @ 9 O'Clock

Pipe Material: **Clay** ☐ Pipe Lined

Invert Depth: **8.70** (ft.) Flow Characteristics: **Fast**

Deposits: ☒ None ☐ Mud ☐ Sludge ☐ Debris ☐ Grease

Infiltration: **None** Pipe Seal Cond: **Unknown**
